# Big Spring Creek Watershed Water Quality Restoration Plan and Total Maximum Daily Loads

**March 2005**  
Version 1.1

Montana Department of Environmental Quality  
Water Quality Planning Bureau

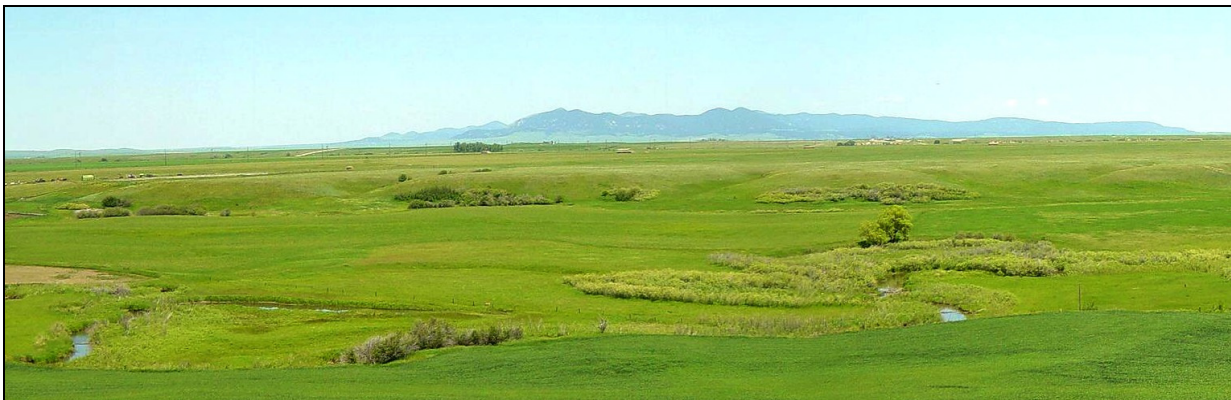
Based on this assessment, combined bank erosion and bank instability are below 20% in all but 3 of 19 reaches. Several reaches had very low to negligible amounts of bank erosion. Riparian degradation ranged from 0% to 83% per reach with an average value of 41% for all of Beaver Creek. Riparian degradation, however, is not considered a cause of impairment in itself, nor does it necessarily correspond to higher levels of sediment input, especially in more stable E-channel systems. For instance, in the case of Beaver Creek, many reaches with a high percentage of riparian degradation also had relatively low levels of bank erosion and instability. Riparian vegetation composition is dominated by trees and woody shrubs and make up over 63% of the riparian cover on Beaver Creek. In many reaches, streamside vegetation is very lush, even though buffer zones may be limited. Figure 4-28 illustrates a typical segment of Beaver Creek. Note that even though riparian degradation is evident, there is very little bank erosion.

**Figure 4-28. Typical Riparian Condition of Beaver Creek (BEA5).**

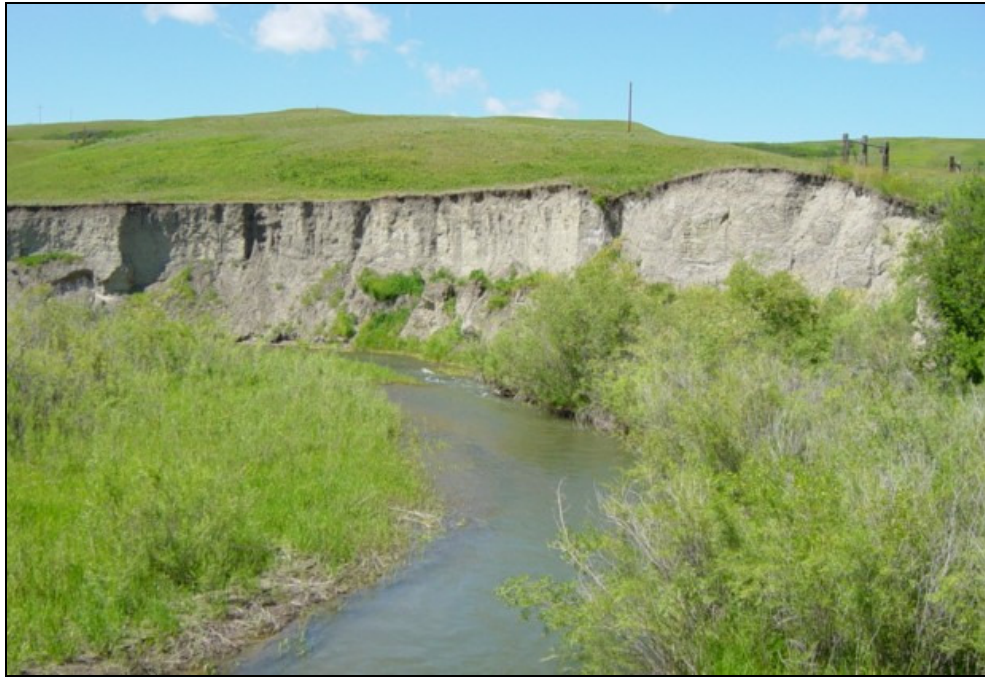
The percentage unstable banks and severe bank erosion on lower Cottonwood Creek, MT41S004\_052, was 6.5% and 6.7%, respectively. Riparian degradation ranged from 0% to 37% per reach with an average value of 20% for segment MT41S004\_052. Riparian vegetation composition is dominated by trees and woody shrubs and make up 75% of the riparian cover on lower Cottonwood Creek. Figure 4-37 illustrates a typical segment of lower Cottonwood Creek, MT41S004\_052 during spring flow conditions (June 21, 2003).

**Figure 4-37. Condition of Lower Cottonwood Creek (COT4).**

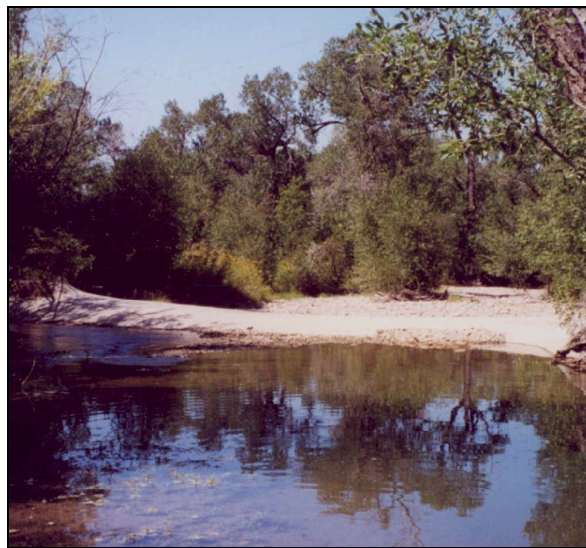
**Figure 4-39. Diversion Dewatering.**

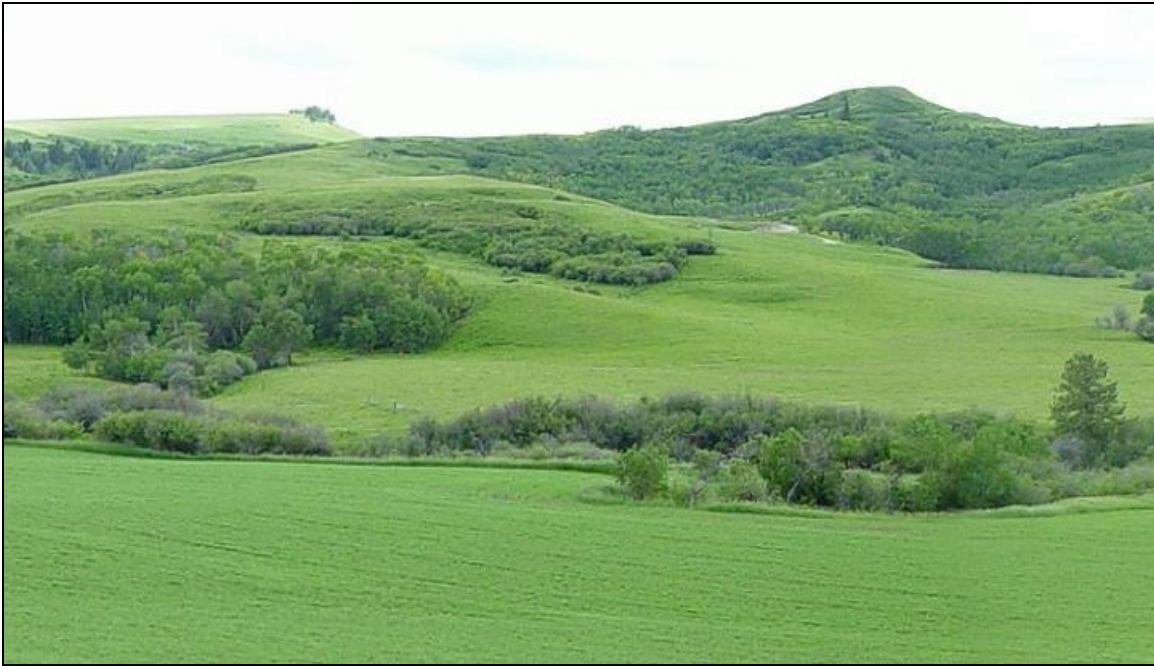
**Figure 4-43. Reach C1 on Casino Creek (June, 2003).**

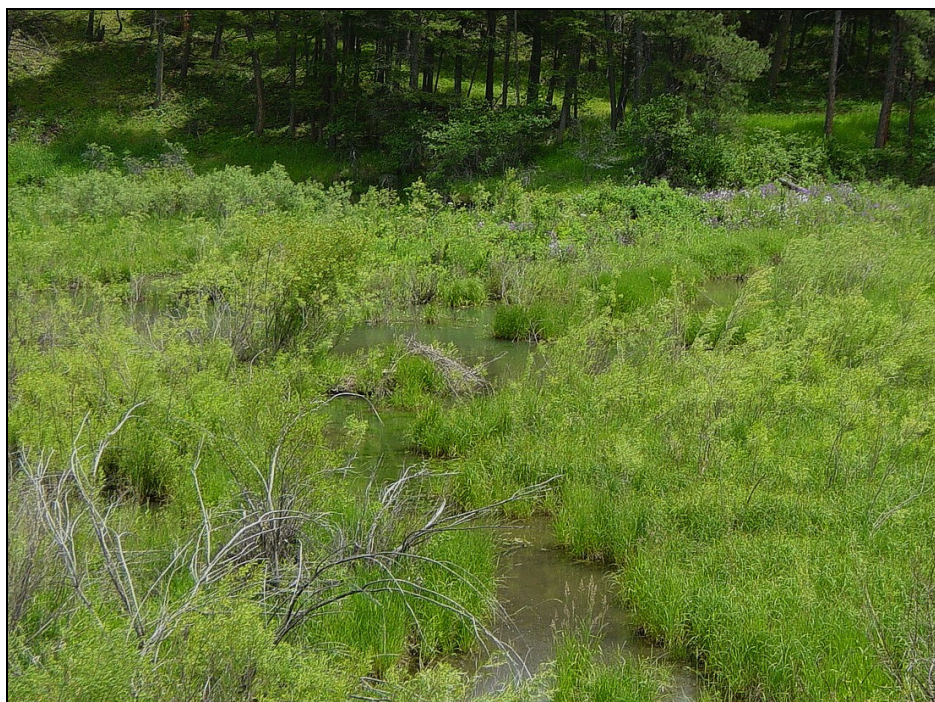
**Figure 4-44. Turbid water associated with beaver complexes (Casino Creek, 2003).**

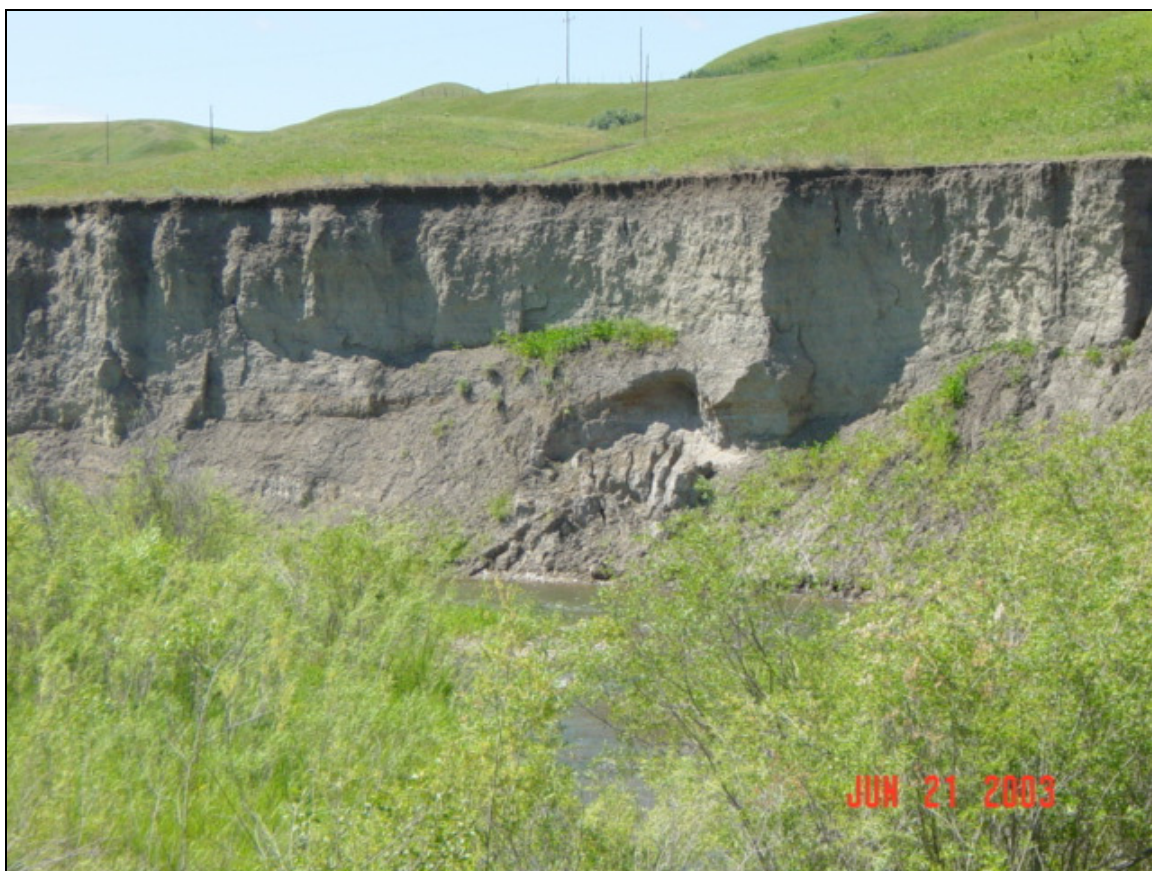
**Figure 5-11. Natural Erosion/Mass Wasting, Big Spring Creek Watershed.**

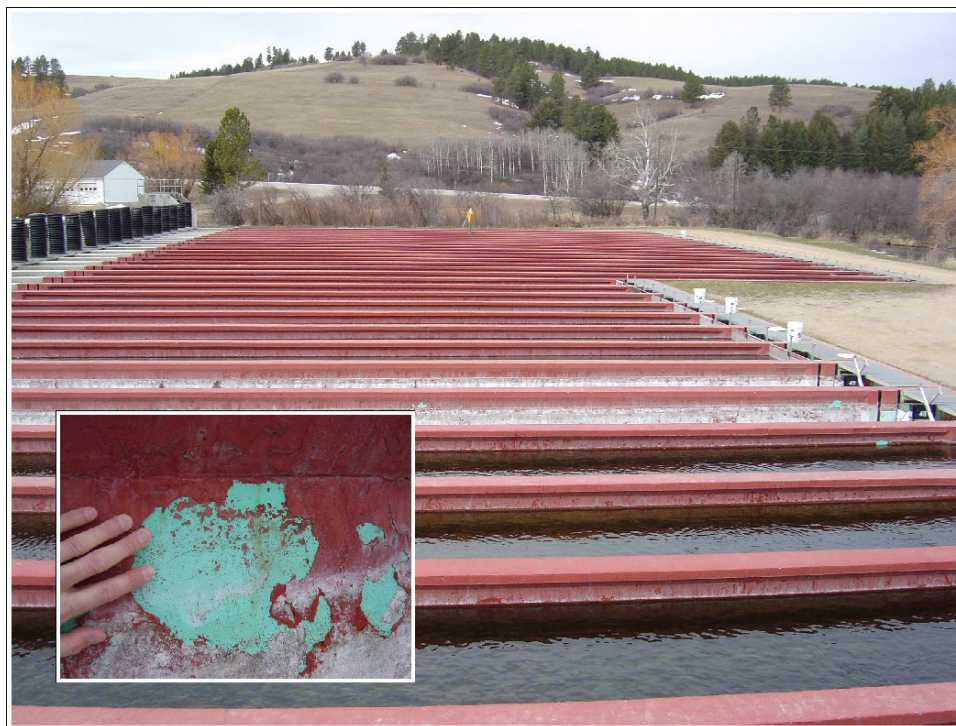
**Figure 6-7. Paint containing PCBs at the Big Springs Trout Hatchery – Lower Raceways.**

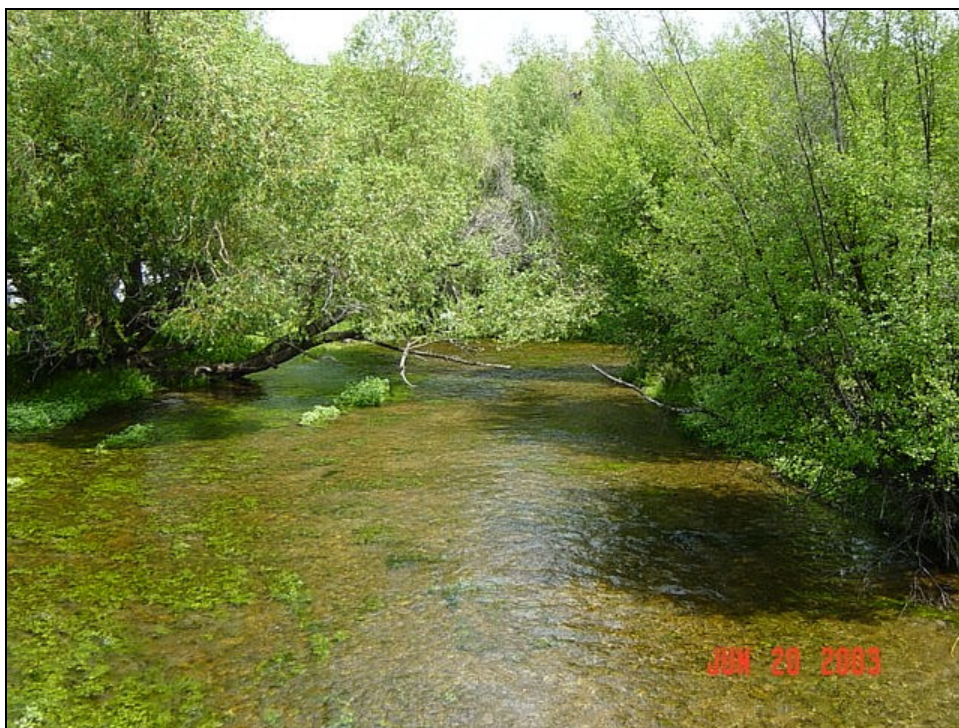
**Figure 7-2. Luxuriant Macrophyte Growth on Upper Big Spring Creek.**

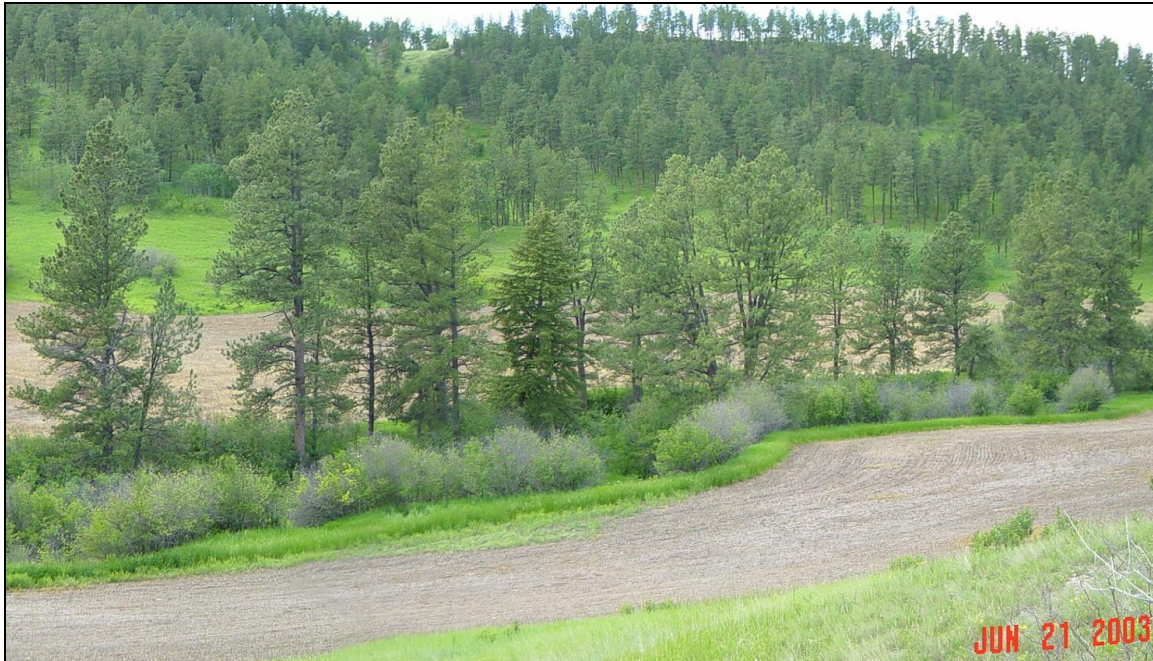
**Figure 8-7. Casino Creek Cropping near the Stream Channel.**
